3**AMIGA**

ISSUE 29 - APR-MAY-JUN 90

SECTION 3 - AMIGA

-
- 29/3-0.0 INDEX - AMIGA SECTION TECHTOPICS ISSUE 29.
 - 29/3-1.1 A2091 MEMORY AUTO-CONFIGURATION LIMITATIONS.
 - 29/3-2.1 A2091 IC MEMORY 262,144 ADDRESS X 4 BIT DRAM.

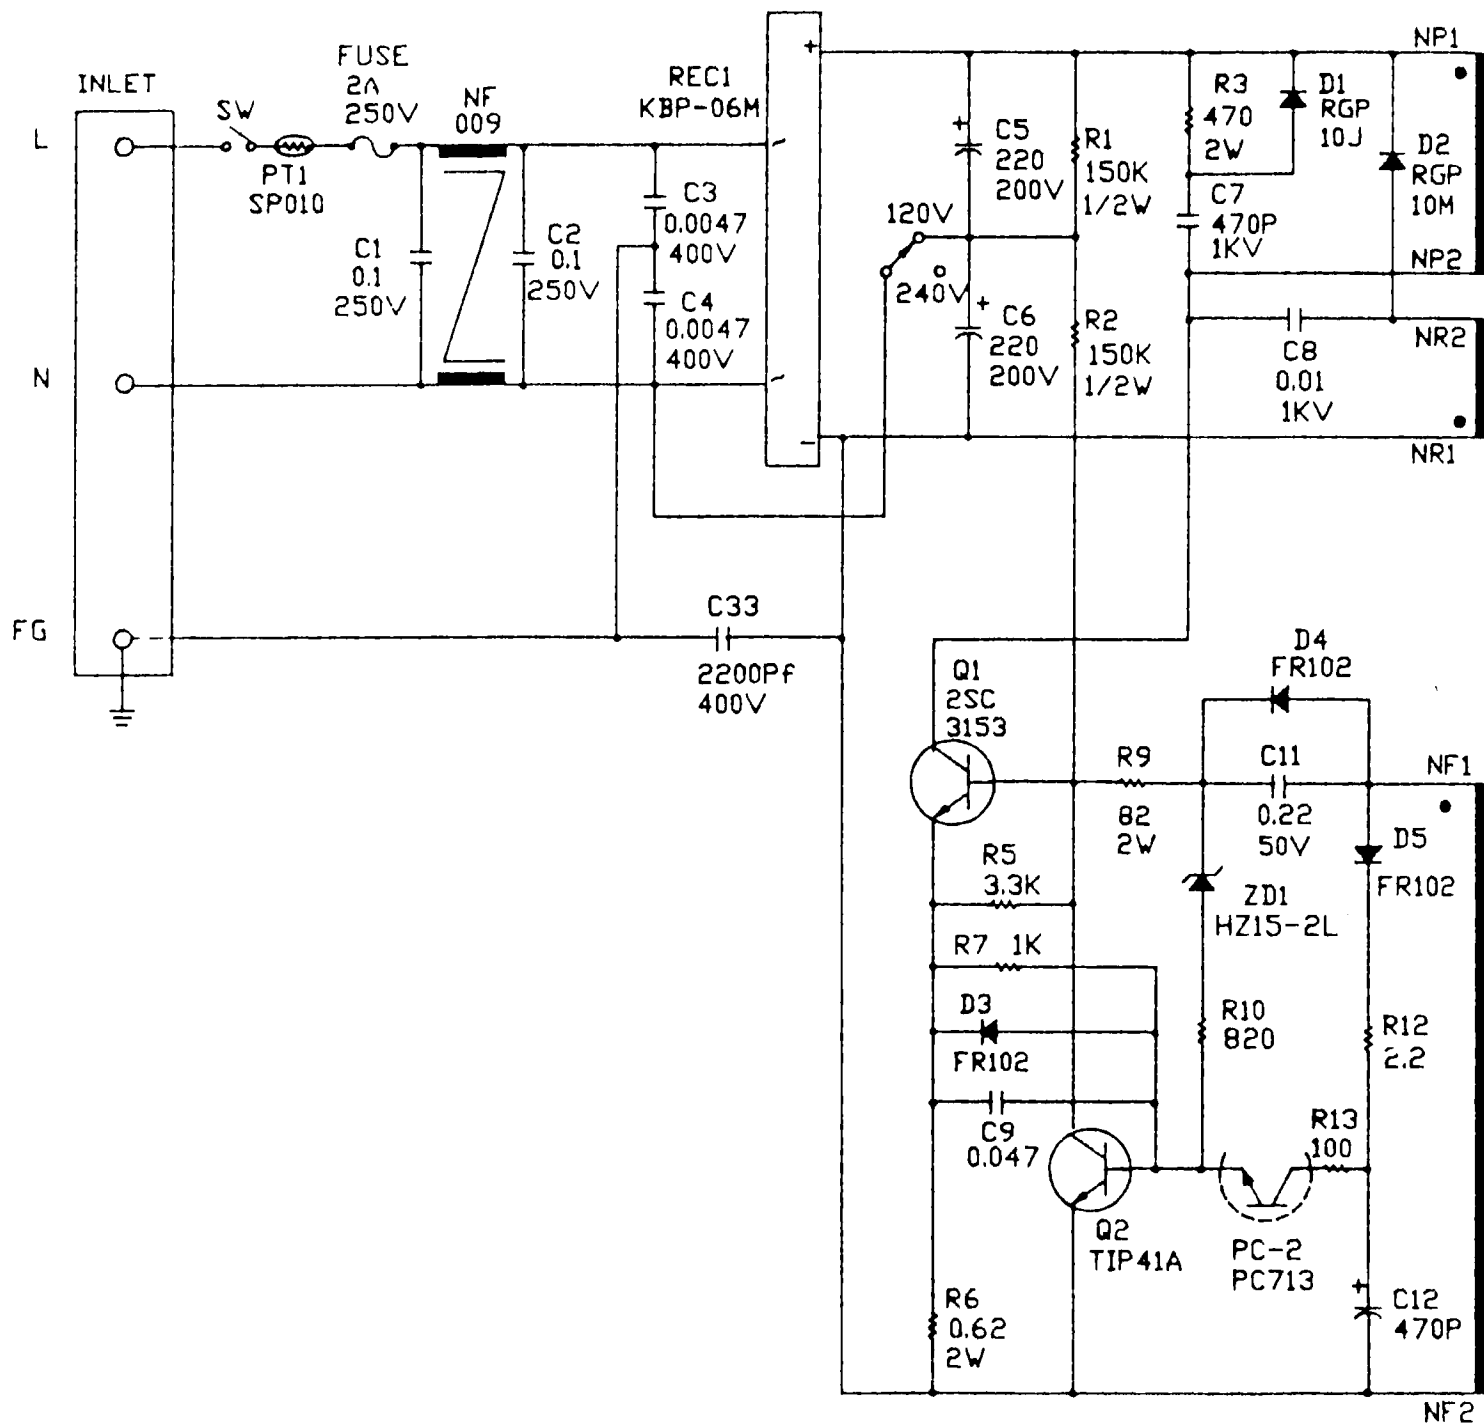
PC10-III POWER SUPPLY Assembly #312637-02

OEM SCHEMATIC FOR PC10-III POWER SUPPLY ASSY #312637-02 IS FOR REFERENCE ONLY. NO WARRANTY COMPONENT REPAIRS ARE AUTHORIZED FOR THIS ASSEMBLY.

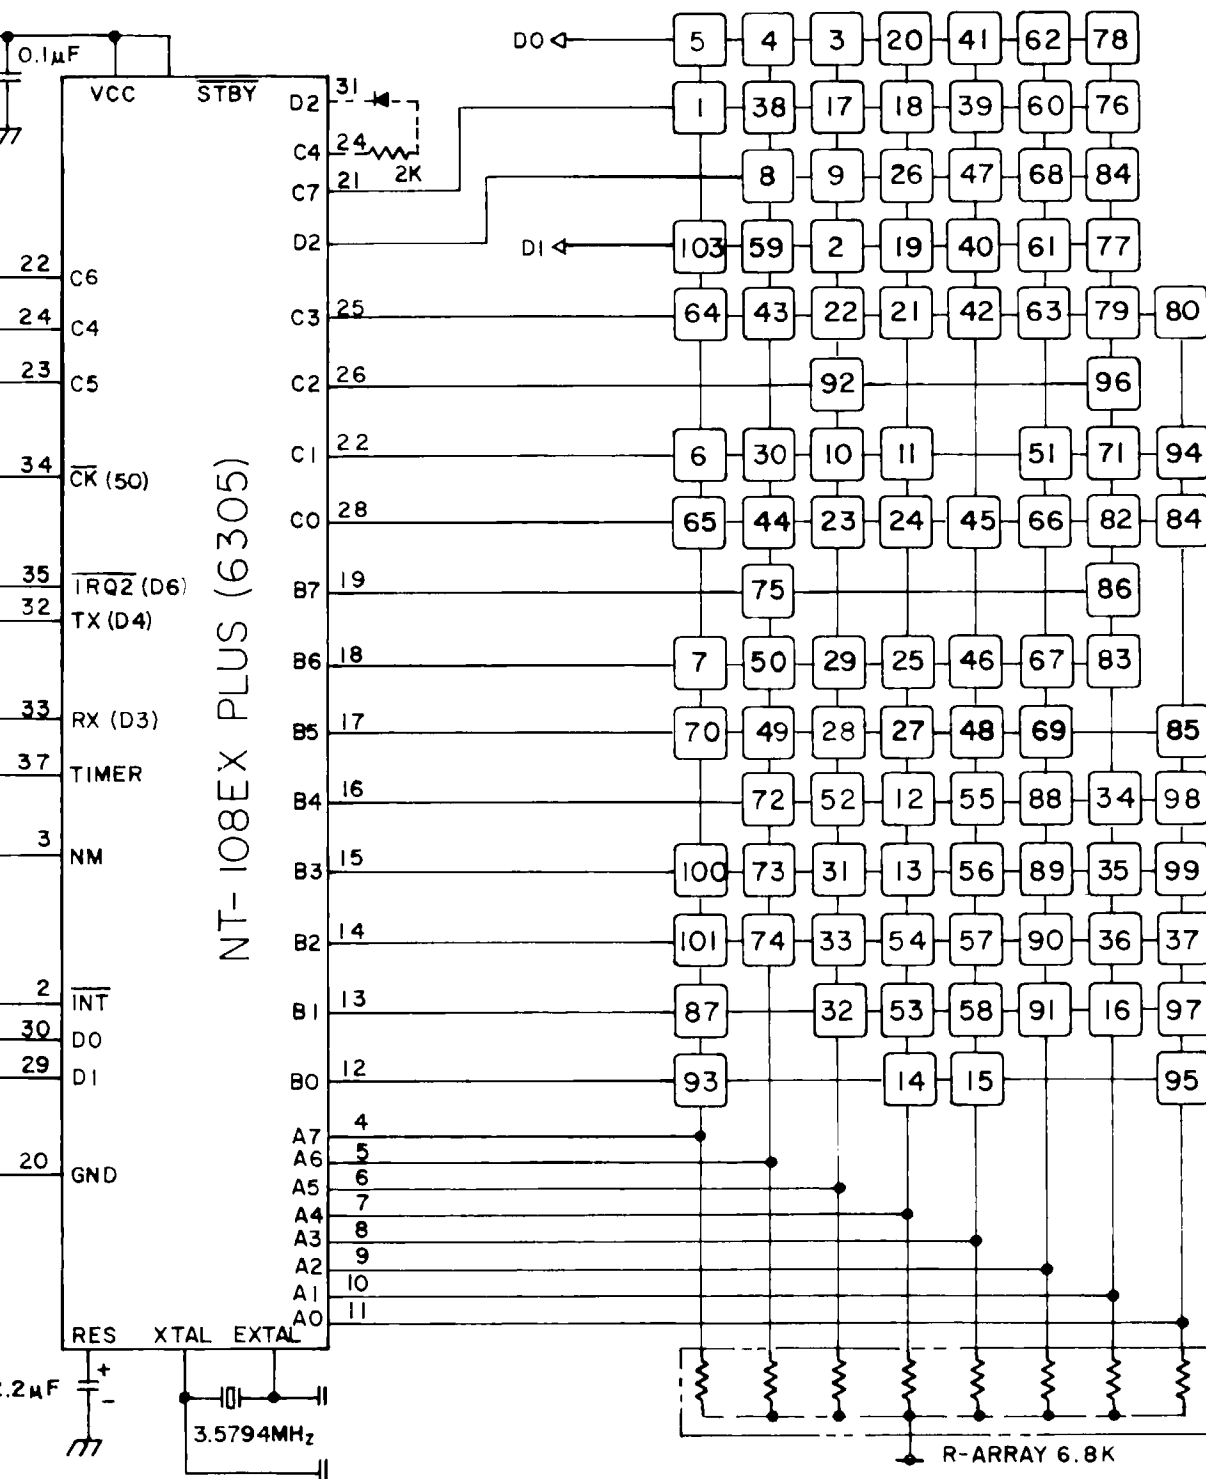
PC10-III KEYBOARD Assembly #312702-02

OEM SCHEMATIC FOR PC10-III KEYBOARD ASSEMBLY # 312702-02 IS FOR REFERENCE ONLY. NO WARRANTY COMPONENT REPAIRS ARE AUTHORIZED FOR THIS ASSEMBLY.
